**NEW
3D AOI**

Innovative
Inspection of PCB
Top and Bottom
Sides

iS6059 Double-Sided Inspection

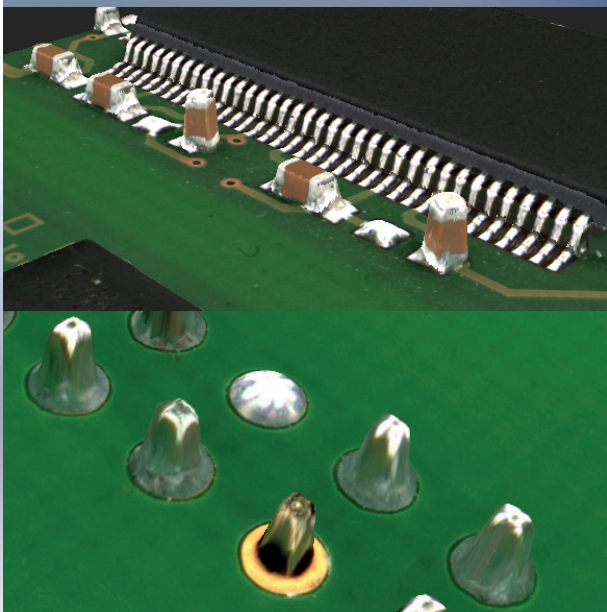
Simultaneous optical quality control from above and below

The iS6059 Double-Sided Inspection is an automatic optical inspection system (3D AOI) for inline use in the electronics manufacturing industry. It can inspect assemblies from above and below without requiring objects to be flipped.

A special feature of the iS6059 Double-Sided Inspection are two state-of-the-art sensor modules (each equipped with 9 cameras and a structured-light projector), which capture images and 3D height information on separate traversing units.

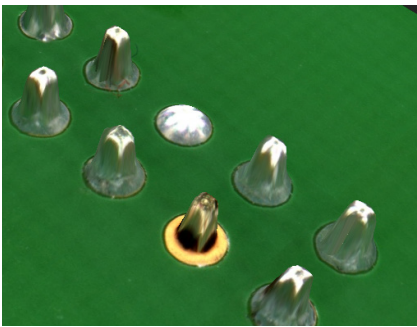
Insufficient wetting (front) and missing pin (back)
